Manhole Inspection Summary

Manhole # S25GG1077MH

Location Address: **1020 41ST ST**

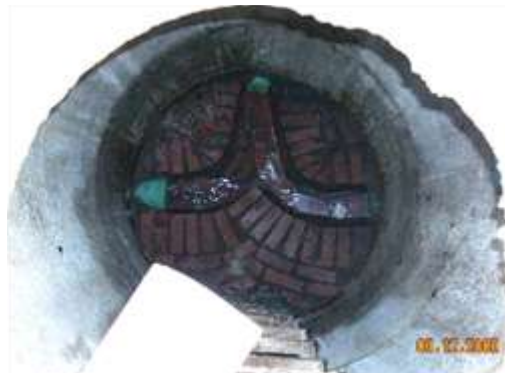
Top View

Bench debris.

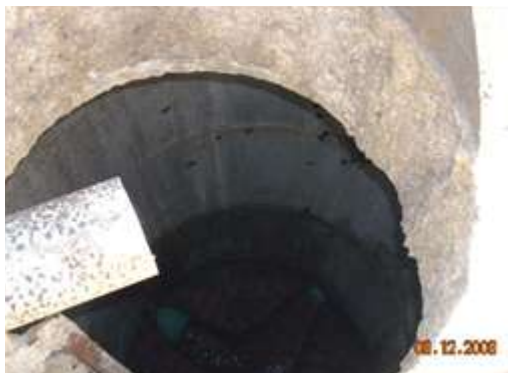
Defect

Frame leaks. Corbel and Barrel infiltration.

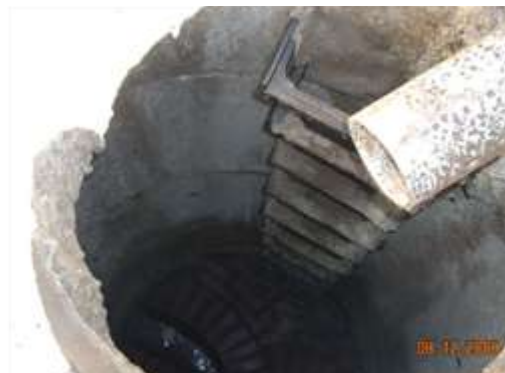
Defect

Frame leaks. Corbel and Barrel infiltration - other side.

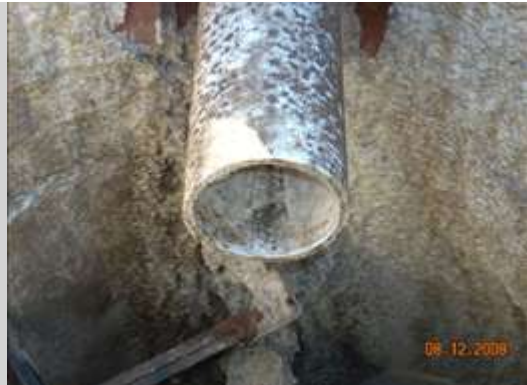
4 in. Circular Gravity Sewer

Infiltration: **Evidence**

Pipe Seal Cond: **Broken**

☒ Possible Illicit Connection

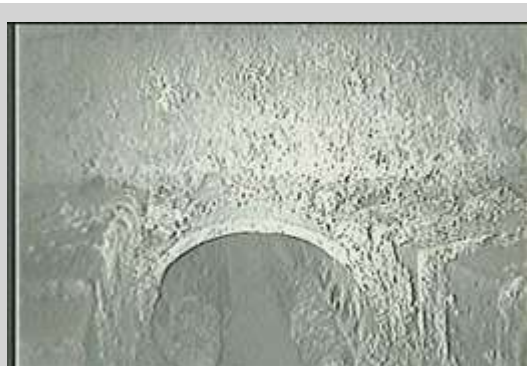
8 in. Circular Gravity Sewer

Deposits: ☐ None ☐ Mud ☐ Sludge ☐ Debris ☒ Grease

Silt Depth: **0** (in.) Deposits Extent: **Light**
